SICHERHEITSMITTEILUNG für AAD

Nummer: 05/2016

**SERVICE
BULLETIN**

1. Issue Date : **September 30, 2016**
2. Bulletin number : **02/09/2016**
3. Subject : **m2 AAD Cutter Replacement**
4. Status : **Mandatory**
5. Identification : **Identification of affected m2 AAD cutters**

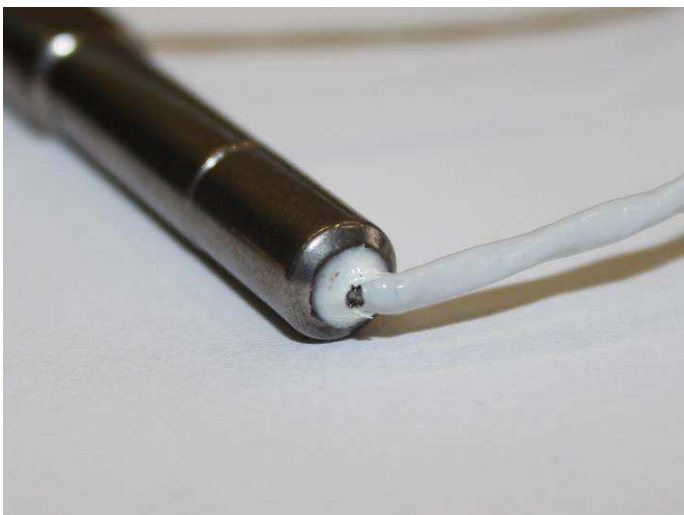
Fig.1

The cutter cable insulation has cracked on some MarS m2 AAD cutters as shown in Fig. 1. Investigation by the manufacturer has shown that this is caused by the method used to close and seal the cutter body. The cracking only affects the insulation, and the function of the device is unaffected. However, as a precaution, all cutters that are affected by this bulletin must be replaced.

a. If a problem exists with the cutter this will be detected by the control unit and displayed as an error No.2. In this case, the cutter must be replaced immediately.

b. If no error is detected, then the AAD may remain in use until the next repack cycle. During the next regular repack the cutter must be inspected and replaced if it is affected by this bulletin.

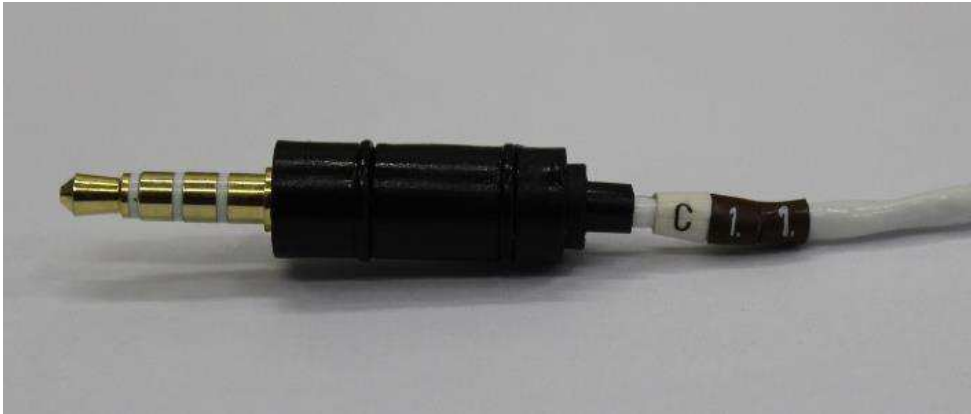
Cutters are marked as shown in figures 2, 3, & 4. The two digit number is the year of manufacture. The letter identifies the production batch. See Annex No. 1 for examples.

Fig. 2 Series C, year 2011 (marked on cutting unit cable)

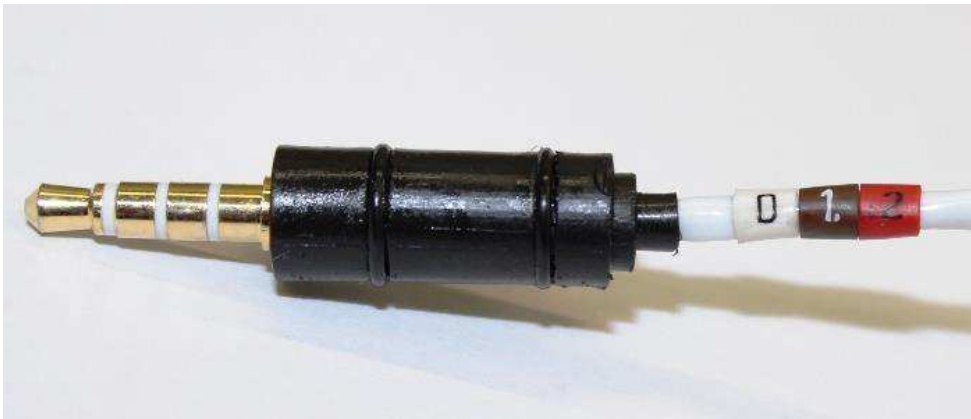
Fig. 3 Series D, year 2012 (marked on cutting unit cable)

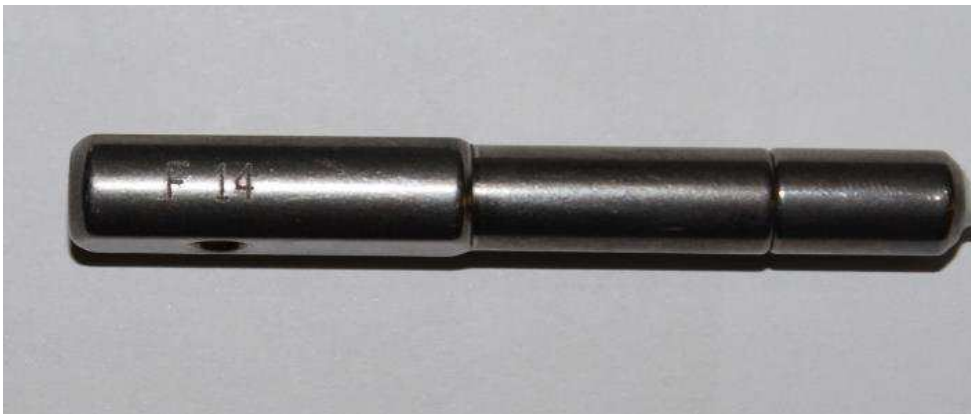
Fig. 4 Series F, year 2014 (marked on cutting unit cable)
